PUBLIC WORKS PROJECT OF THE YEAR AWARD NOMINATION FORM

Project Name
Memorial Fountain Restoration

Memorial Fountain Restoration

Project Overview

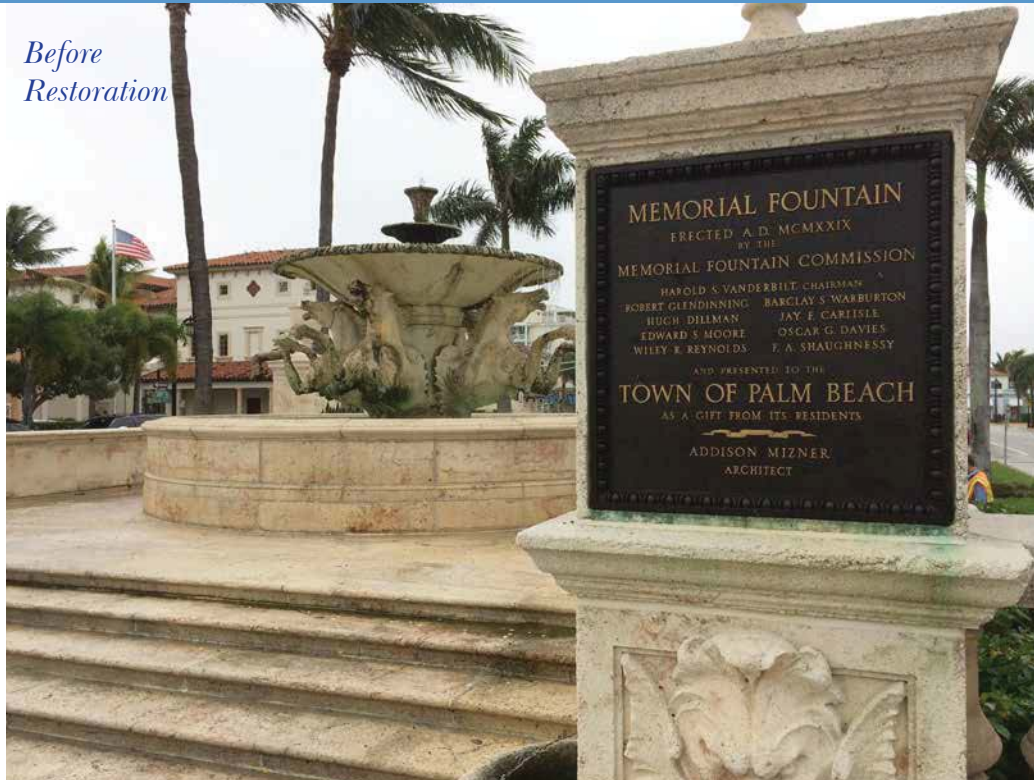
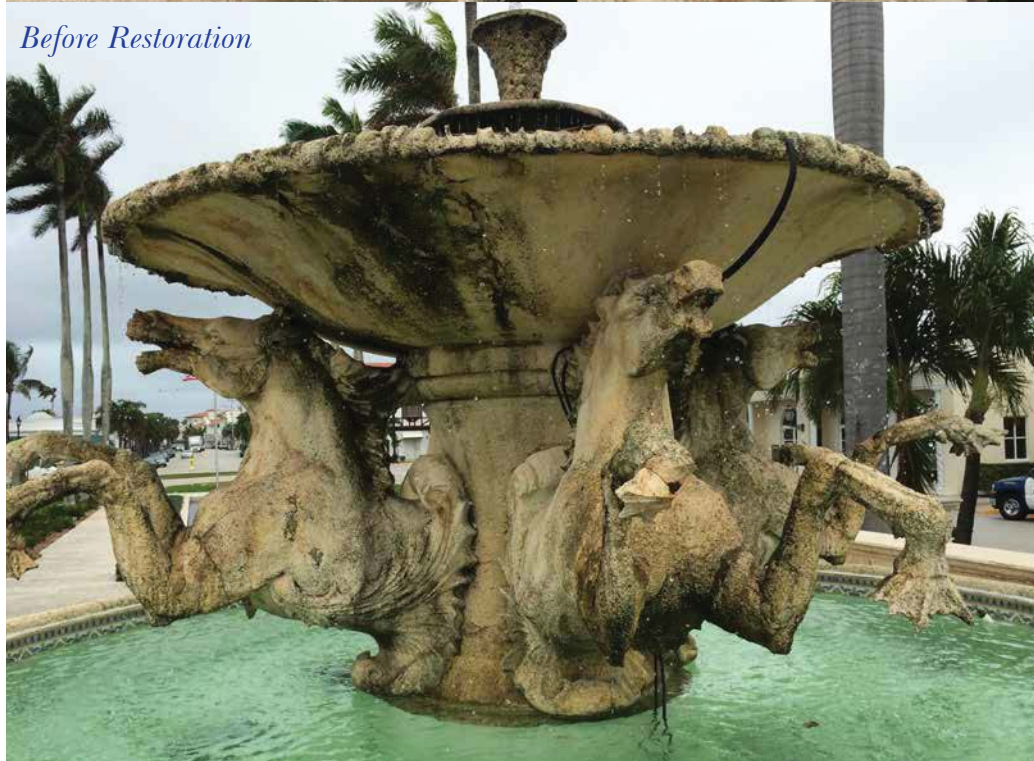
*Before
Restoration*

Scarred by corrosion from the tropical climate, harsh weather, and scouring from the fountain's normal water flow, it needed more than a simple facelift. Portions of the fountain were worn away, especially artistic details on the hippocamps and top stem. Structurally, large cracks had formed and some of the supporting steel reinforcement was exposed to the elements.

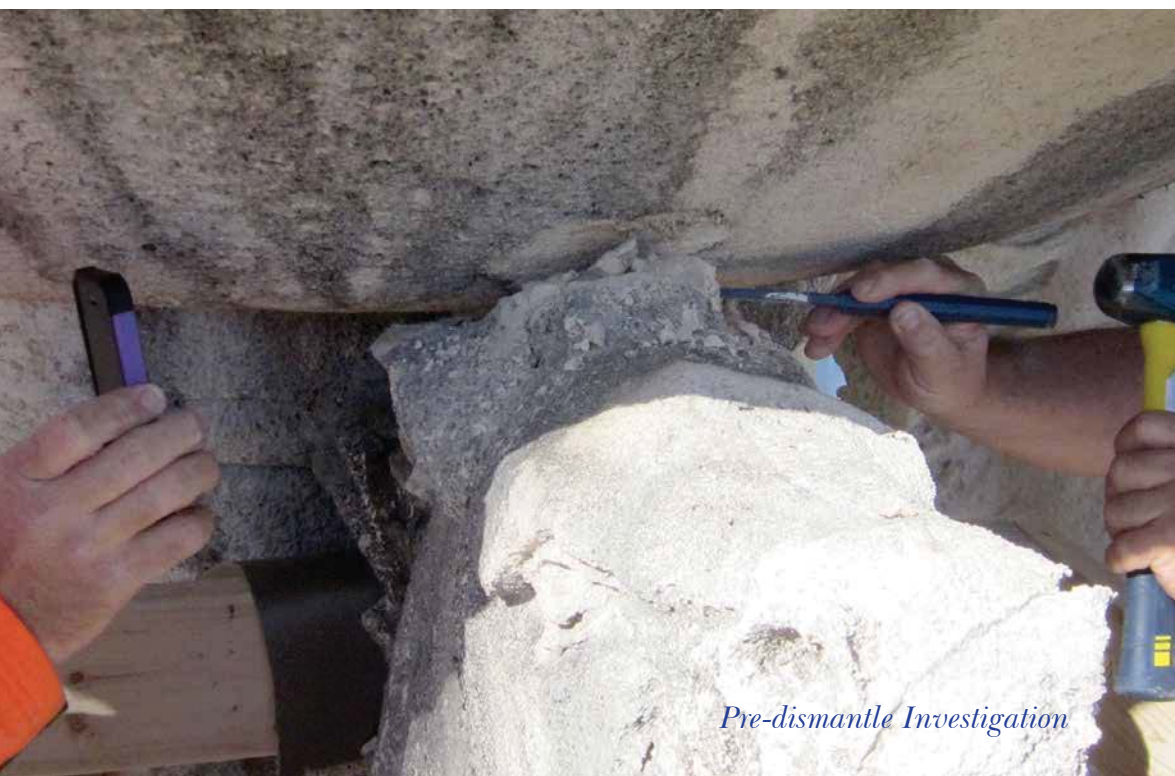
Pre-dismantle Investigation

restoration. Selective pilot holes were drilled into the base to decipher how the fountain's elements were held together. This helped guide the team to best preserve each portion (top stem, pedestal, two basins, and four hippocamps) as they set out on the difficult task of removing these 85-year-old works of art. All these steps were chronicled and conducted under the watchful eye of conservator Mark Rabinowitz, with Conservation Solutions, Inc. (CSI).

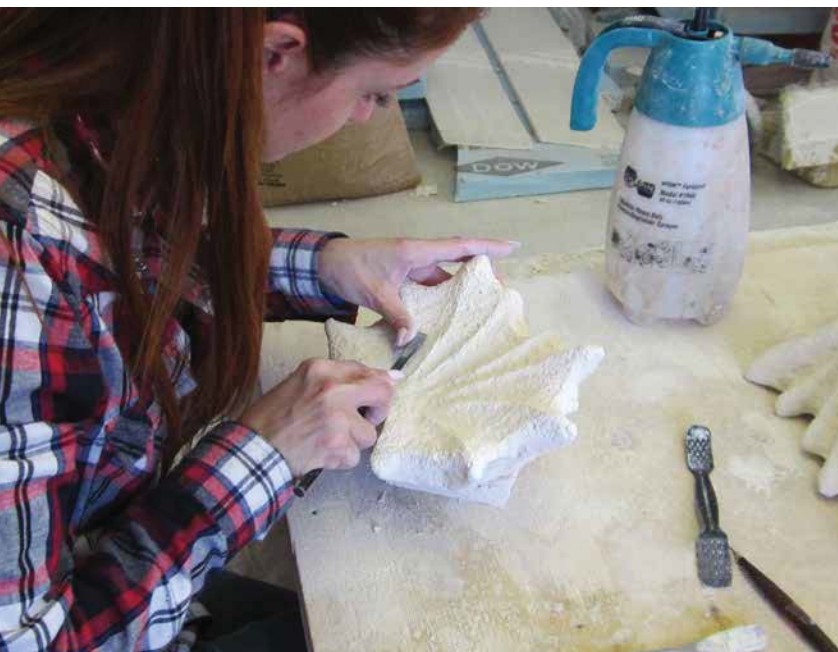
Since the team did not know what would happen when one element was removed, they constructed individual protective crates around each hippocamp as a precaution. Surgically cutting the figures from the base during a two-day process, the team painstakingly dismantled the cast stone fountain. Each hippocamp was housed in its own specially-built crate onsite and carefully transported by truck to Clifford Restoration in Ontario, Canada. This internationally recognized restorer is home to specialized artisans and its own in-house conservator.

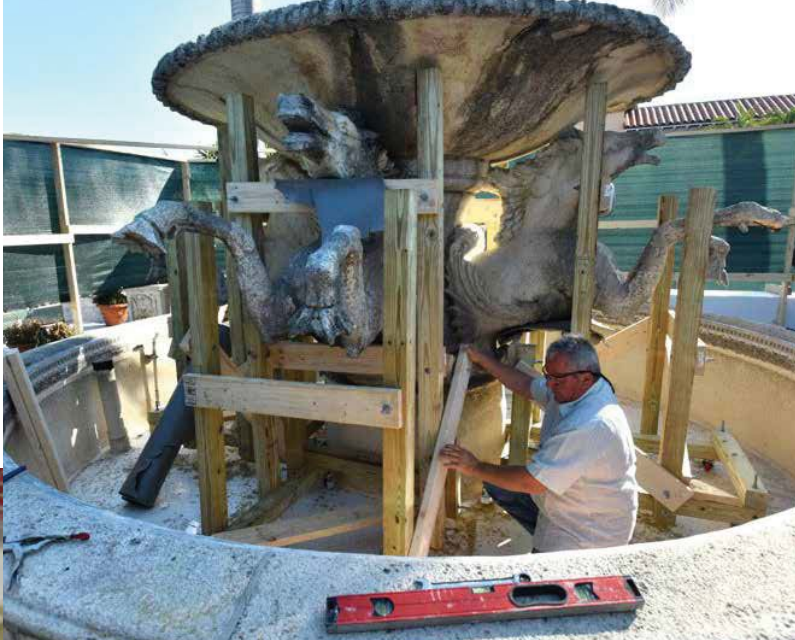
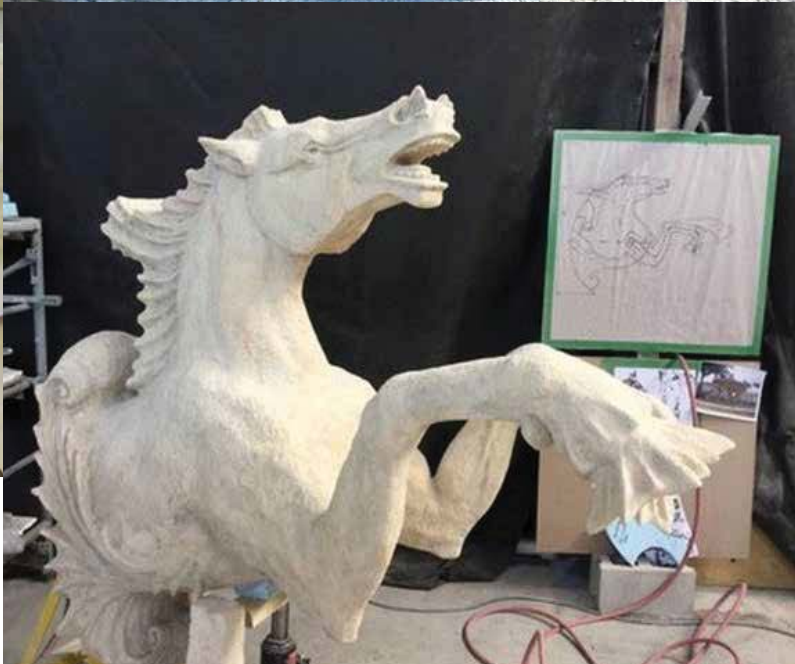
By mid-April, the Town and consultants approved the models to cast new pieces for the hippocamps consisting of new legs and surface treatments to restore the hippocamps' faces and manes. In addition to the visual restoration, the original steel reinforcement was replaced with stainless steel reinforcing rods. The once broken and dingy figures were given a new life.

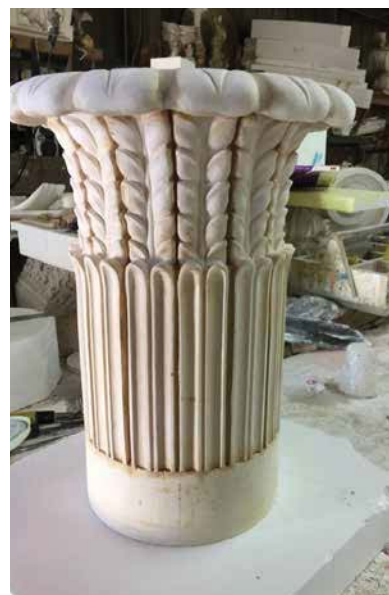
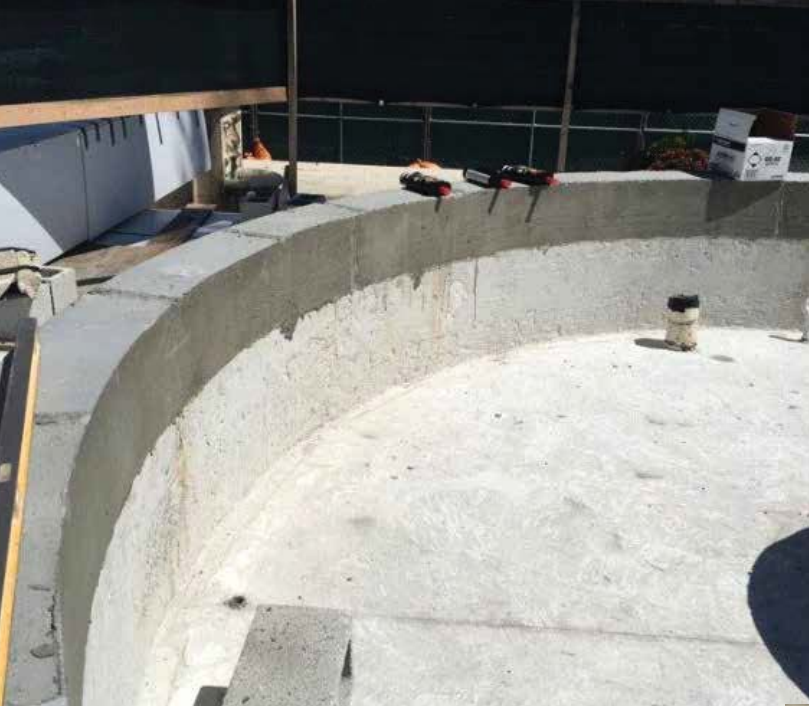
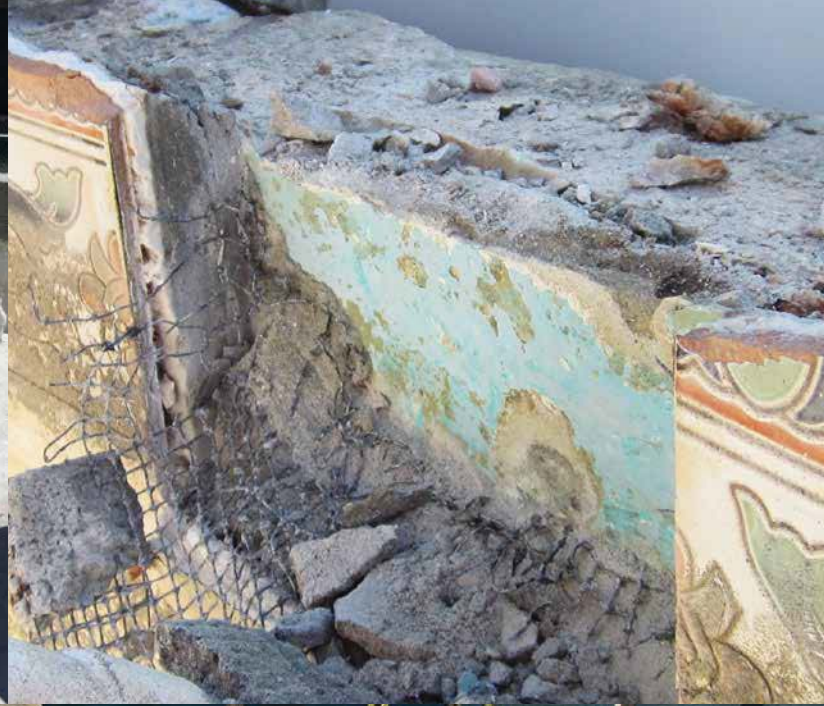
At the same time the hippocamps were transported to Canada, the fountain's upper and main stems, pedestal, and two bowls were transported to Premier Stoneworks in Delray Beach, Florida for reconstruction. These pieces also suffered extreme deterioration and were reproduced using details from old photos. Premier Stoneworks also fabricated the fountain's basin cap stone and veneer. Special care was taken to replicate the original water flow the fountain created off the edges of the stem and bowls. Water flow tests were conducted and modifications were made to the design so the water could cascade as it originally did in 1929.

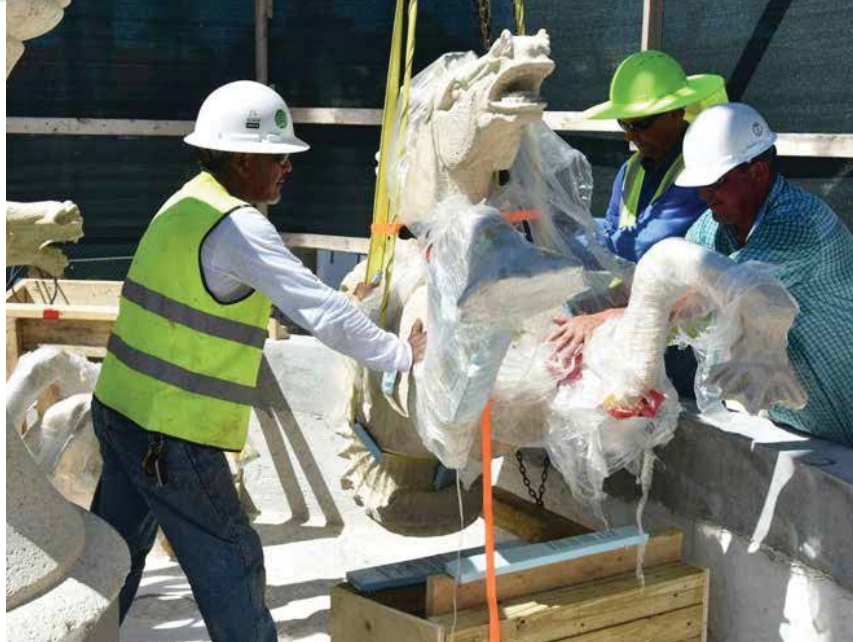
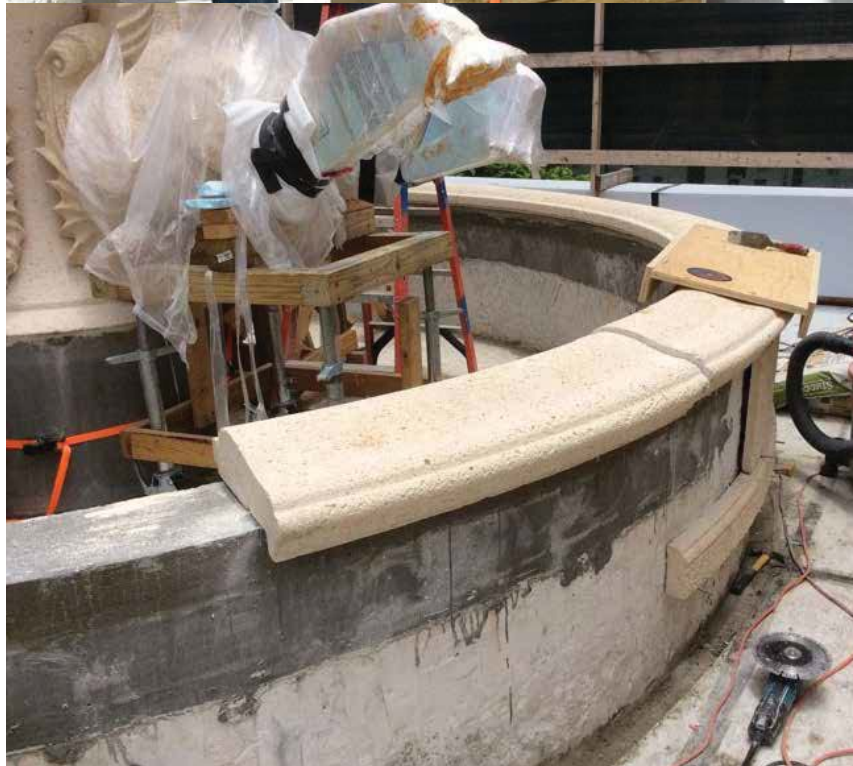
The construction team was extremely cautious with the dry fitting process and made sure everything was measured correctly and no damage was done to the restored hippocamps. Stainless steel metal rods were used to support the figures and were connected inside the fountain's base once the exact alignment was determined. The team also ensured the hippocamps were level so that water properly flowed from the large lower bowl. Adhesives were used to affix the hippocamps to the base.

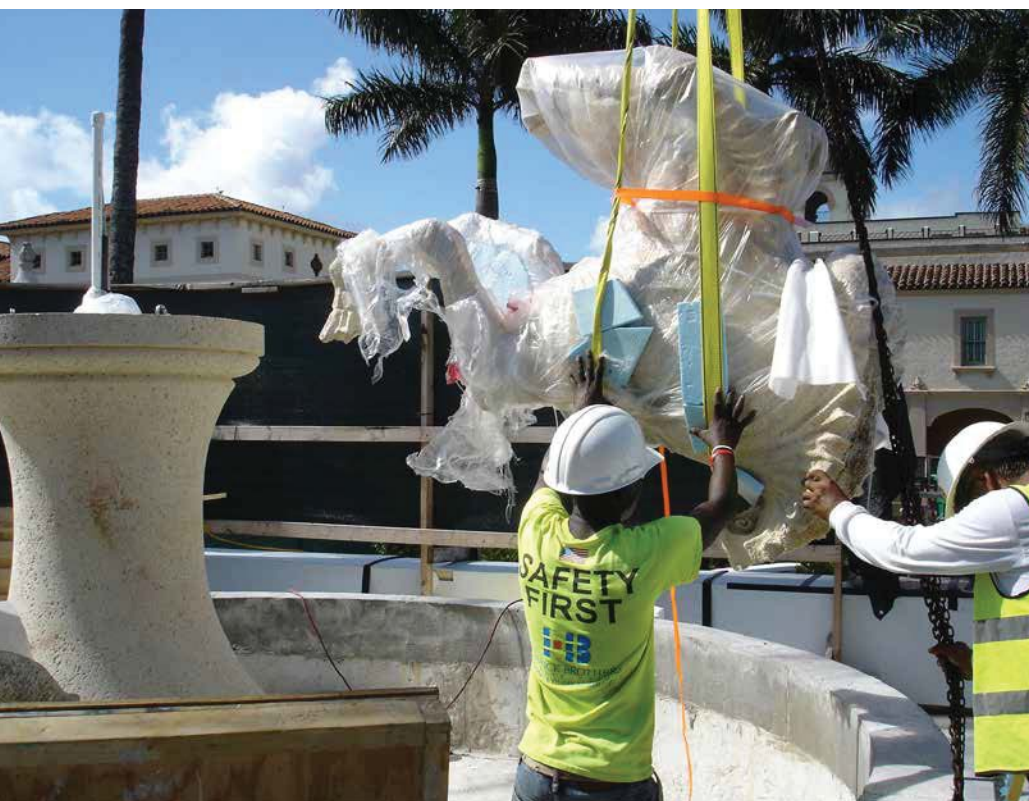
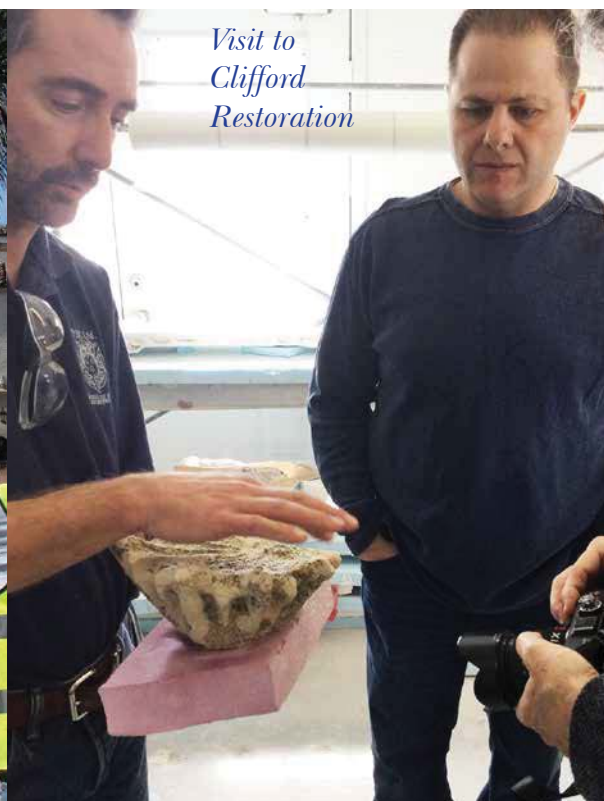
*Visit to
Clifford
Restoration*

During the project, team members made on-site visits to Clifford Restoration and Premier Stoneworks to check on the status of restoration and reconstruction work. But for more frequent status updates, the team utilized video conferencing, saving both time and money.

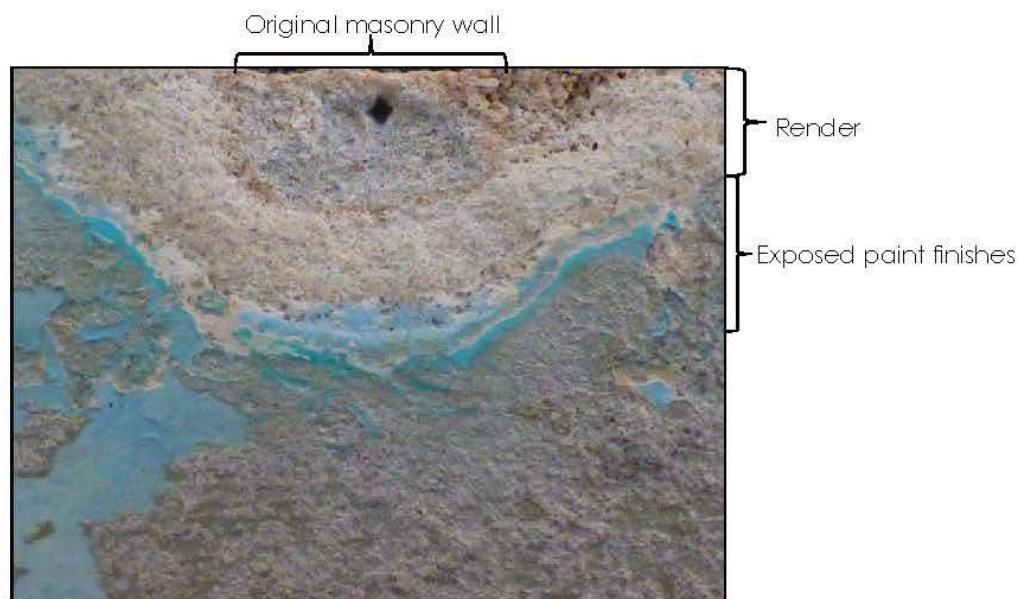
Figure 5: Detail of exposure on bulk sample.

In the finish analysis, at least six (6) different paint finishes were identified. Two (2) of the most complete and representative samples are included in Appendix A – Paint Layer Stratigraphy Analysis. In the stratigraphy analyses, samples are shown in a standard orientation, with the earliest (original) finishes at the bottom and the most recent finishes at the top.

A lack of definition and dirt layers between the render and paint scheme 1 suggests that scheme 1 was applied during the same campaign. A lack of definition and dirt layers between scheme 1 and 2 suggests that scheme 1 (white) is a primer layer and scheme 2 (light cyan blue) is the first finish layer. The presence of large aggregate at the surface of the render suggests it was not designed to be a finish layer. Exposures on the bulk sample confirmed that the render, scheme 1 and scheme 2 were well integrated and difficult to separate.

Analysis of the samples suggests that the original pool lining was a simple, continuous blue color on top of a white render and primer layer. The scheme identified for re-creation (scheme 2) most closely matches **Munsell 10B 8/4**. This translates to the **Benjamin Moore color 2061-60, "Little Boy Blue."**

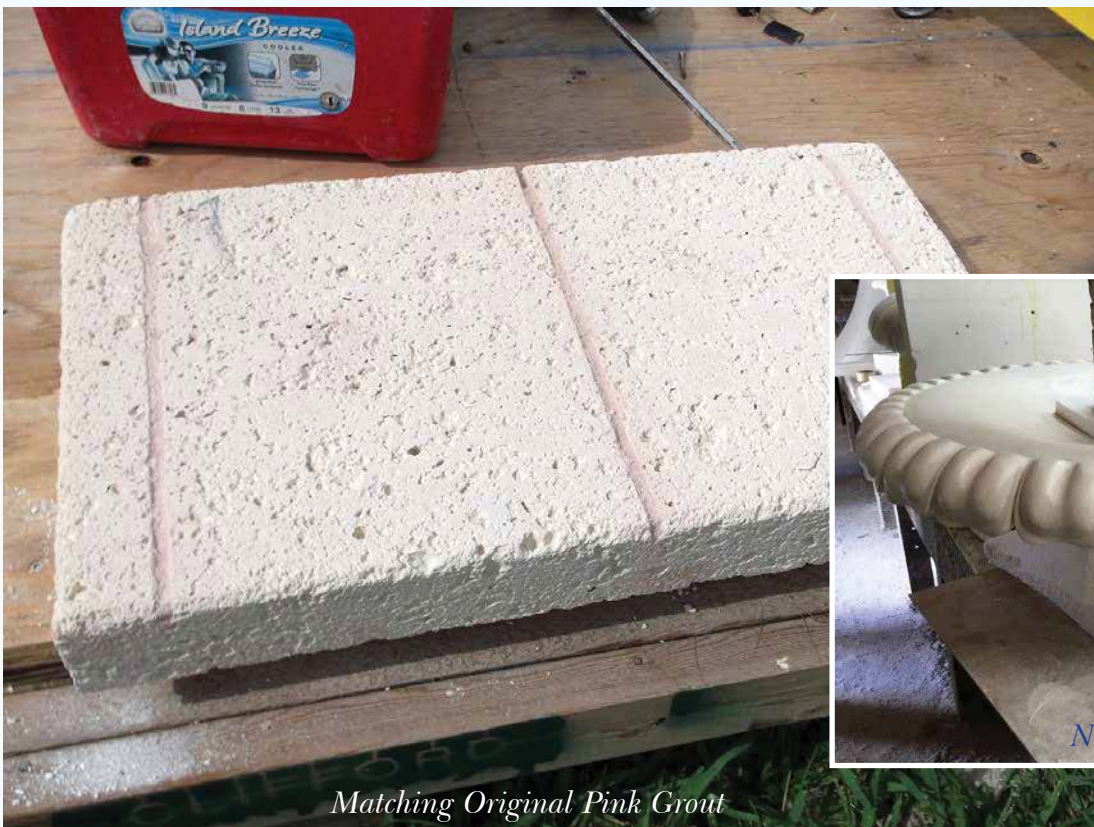
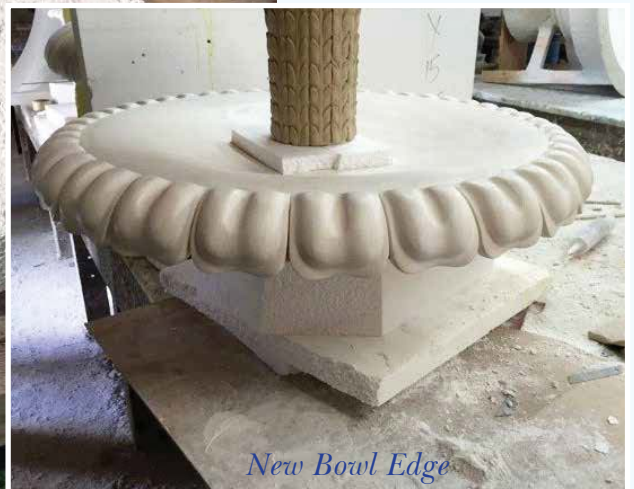
Matching Original Pink Grout

Every effort was made to return the fountain to how it originally was, including the special forensic testing to determine the original colors for the paint in the basin and grout for the basin veneer stones. The use of historic photos to reconstruct damaged portions of the fountain and replication of the original water flow added to the quest to turn back time, while giving the structure a future.

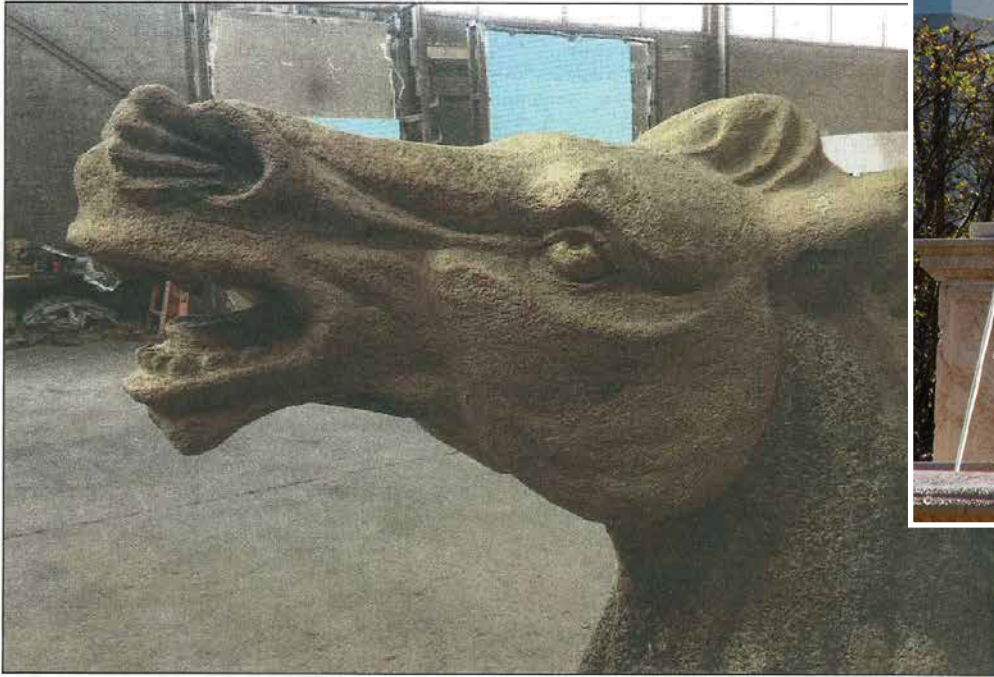
A rebuilt hippocamp sports well-defined features. The team reviewed equine anatomy to give the horses the sharper, more vigorous look they had originally. See restoration video, PalmBeachDailyNews.com

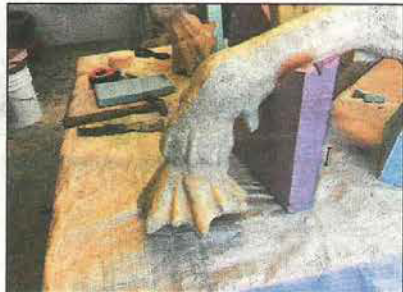
A model hippocamp leg has a webbed hoof.

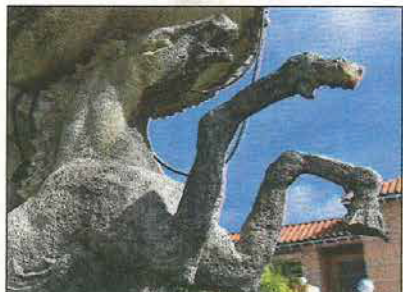
A view of an unrestored hippocamp figure shows the deterioration it has suffered.
