## Something old, something new on King Blue project

Dan O'Reilly April 27, 2018

Designed by IBI Group and overseen by construction manager EllisDon for the Greenland Group, the King Blue Condominium project includes the construction of two condominium towers (48 and 44 storeys) and an eight-storey podium with a five-level underground garage on the site of the former Canadian Westinghouse building.

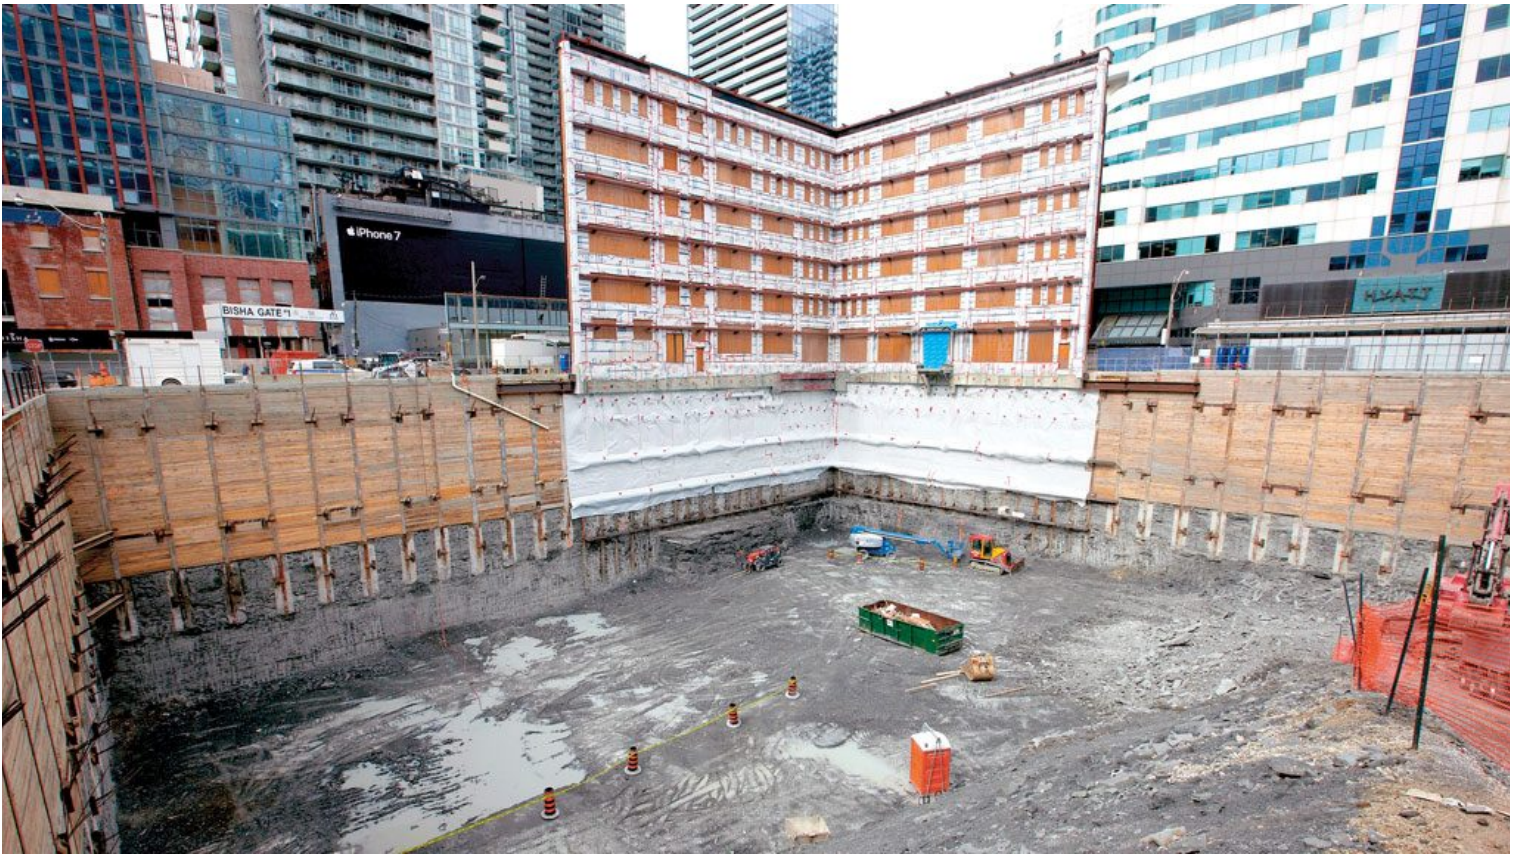
LENSCAPE INCORPORATED—The original façade of the Westinghouse building, along King Street and the adjacent Blue Jays Way side street, was preserved during demolition thanks to the steel truss support .

The Toronto structural consultant designed an exterior steel truss bracing system which supported the façade while demolition of the building and the subsequent excavation of a five-storey underground parking garage were being conducted.

Erected by Pengelly Iron Steel during the first three months of 2016, the trusses rested on grade beams which, in turn, were supported by micropiles. This allowed the existing footings to be fully removed during the excavation of the underground garage, says structural designer Henry Song.

After the micropiles, grade beams and steel trusses were in place, the heritage wall was restrained at each level by steel members penetrating the windows tied to longitudinal members that “clamped” the wall. Wood block shimming was used to allow for thermal movement without damaging it, says Song.

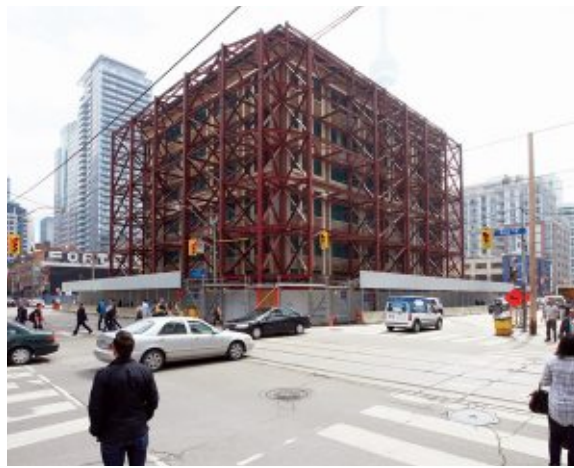
LENSCAPE INCORPORATED—The steel truss support system was designed by Jablonsky AST and Partners.

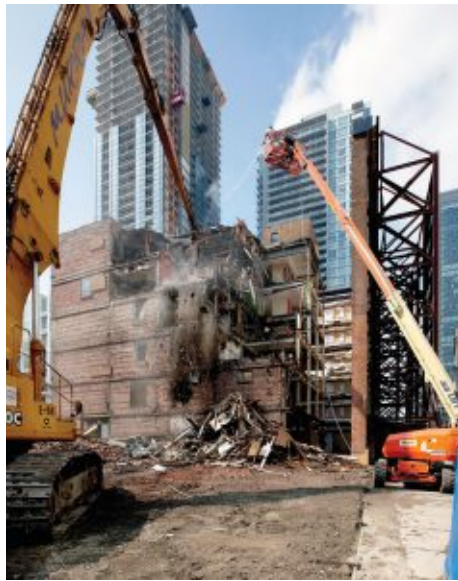
LENSCAPE  
INCORPORATED—Construction of the King Blue Condominium project required intricate demolition of the former Westinghouse building whose facade was preserved by a unique steel truss system.

Preserving the heritage façade, which “floated” over the garage excavation, and then reconnecting it to the podium has been the most challenging phase of the entire project, he says.
