Posted: 10:00 p.m. Saturday, April 25, 2015

## Returning Mizner's vision: Memorial Fountain restoration turns corner

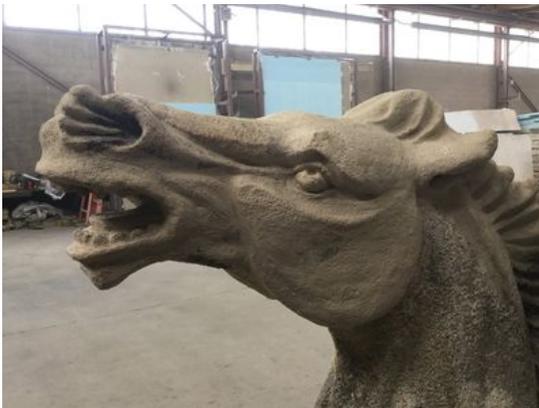
Courtesy of Clifford Restoration

In Ontario, Canada, the staff of Clifford Restoration has brought back the muscular features of the north hippocamp's face and torso, removed cracks and is giving the horse of the sea a new pair of legs.

Clay added to its face, mane and torso effectively erases the damage that water and metal corrosion have created over the years. These temporary "mock-up" features will soon be cast in a concrete and keystone (cut coral) mixture and applied or—in the case of the legs, attached.
